Microscopic, chemical, and molecular-biological investigation of the decayed medieval stained window glasses of two Catalan churches

Guadalupe Piñar^{a,*}, Maite Garcia-Valles^b, Domingo Gimeno-Torrente^b, Jose Luis Fernandez-Turiel^c, Jörg Ettenauer^a, Katja Sterflinger^a

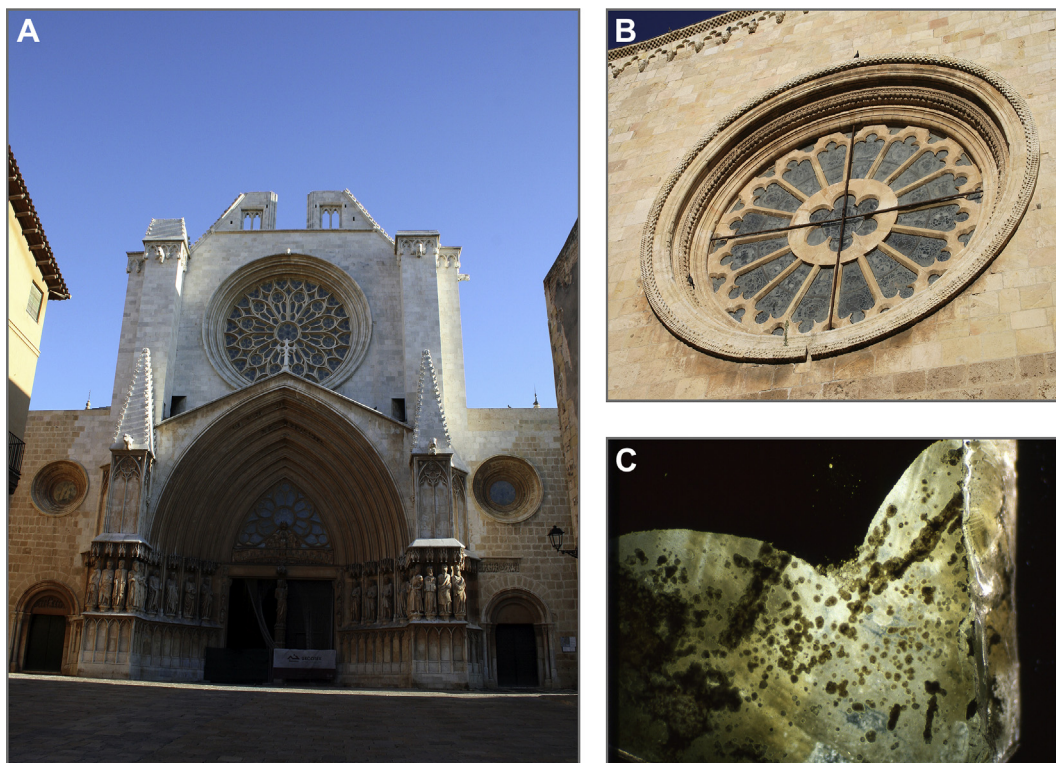
Fig. 1. Cathedral of Tarragona. 1A: Detail of the façade. 1B: Detail of the rosette glasses of the transept from the Cathedral of Tarragona. 1C: Detail of a glass piece with deterioration signs looking like *Cladosporium* attack.

The rosette glasses of the transept from the Cathedral of Tarragona (Fig. 1) date back to the beginning of the 14th century. They show evidence of damage and repair after the War of Independence (1808–1812) as well. All stained glass windows show original black-fired draws (grisailles), but our present study is only concerned with the composition and corrosion of the main pieces of glass.

Some samples showed a leached surface (Figs. 1C and 3A left) and also evidence of a gel with a silica composition, as determined by SEM. The more external part of the patina showed to be orange and the bottom beige (Fig. 3A, left). Occasionally, the patina was formed in glass surfaces previously attacked by microorganisms (Fig. 3A), producing a more or less penetrating pitting into the glass (Fig. 3B). This destroyed surface can also be filled (constructive activity) with authigenic minerals (patina).

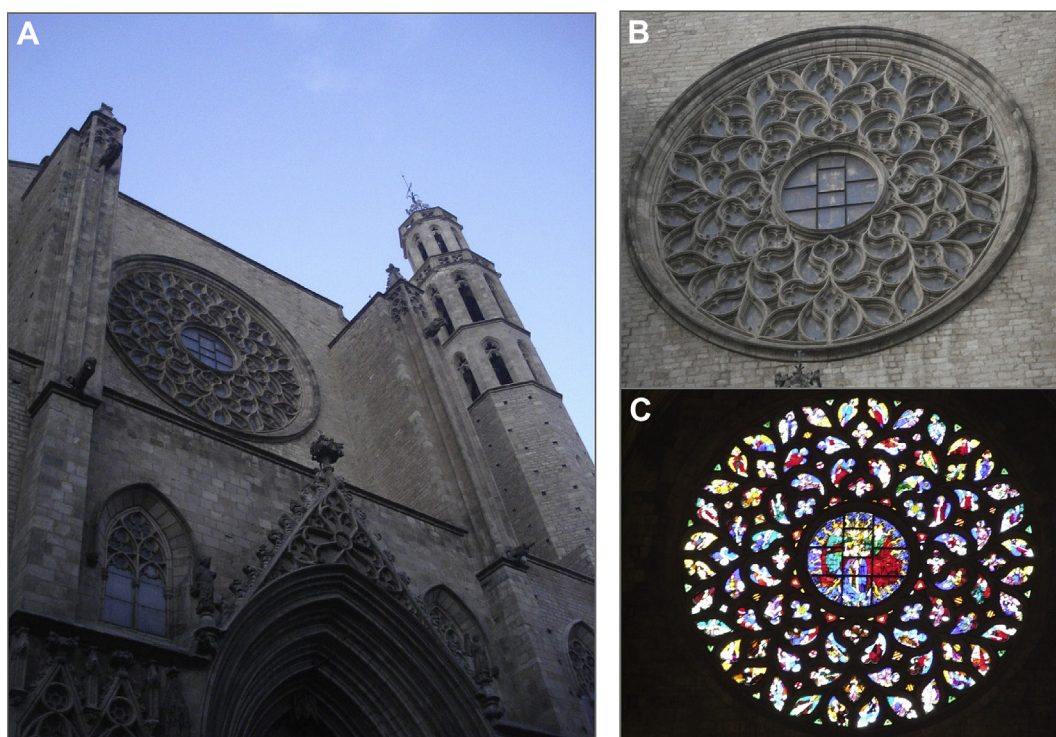
Fig. 2. Church of Santa Maria del Mar, Barcelona. 2A: Detail of the façade. 2B: Detail of the outer rosette glasses. 2C: Detail of the inner rosette glasses.

The church of Santa Maria del Mar in Barcelona (Fig. 2) is a medieval building erected in the 14th century but the large rosette on the main façade was destroyed by the 1428 Pyrenees earthquake and the stained glass window was rebuilt during the 15th century. Over the centuries, damage and repairs have led to a mixture of old glass panels and new ones, with the most important modifications probably dating from the Spanish War of Independence and the Spanish Civil War (1936–1939) (Ainaud de Lasarte et al., 1985).

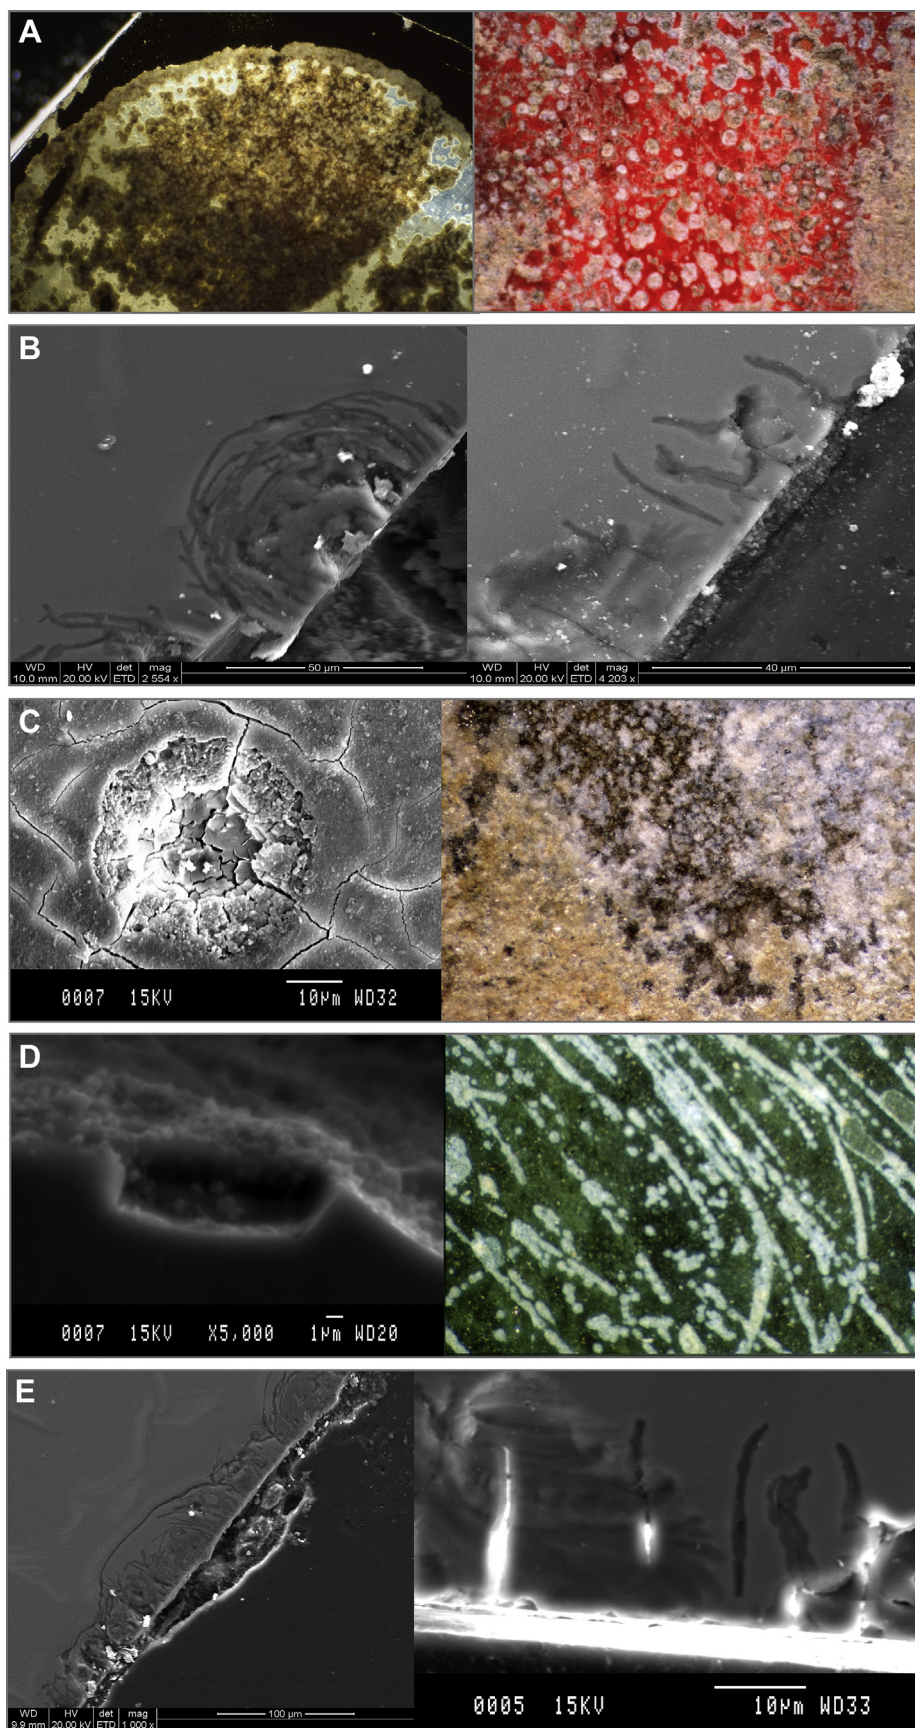
Fig. 3. Patina, leaching surface, and bio-pitting observed on glass samples. 3A: Macroscopic pictures corresponding to two Tarragona glass samples. Left image shows silica-leached surface directly in contact with glass and before patina (orange at bottom and more dark at top) developed in sample T-5. Right image shows detail of patina and bio-pitting

developed in red glass plaqué in sample T-6. 3B: SEM analyses on sample T-6 show the degree of penetration of this activity into the glass. 3C: Orange and beige patina developed in red plaqué glass (sample T-35). Glass and patina have been affected by biological activity observed as small pits. The SEM picture shows the pit evolution to inner part. 3D: Decayed surface corresponding to sample STM-16 from Santa Maria del Mar. The right image shows circles isolated or one after the other forming a row arranged in a preferential direction. Occasionally there is an alignment perpendicular to this main direction. The left image, observed with microscopy in the thin section perpendicular to the glass surface, shows the pit penetration in the green glass zone. This penetration was short, due to the toxicity of the saturated copper, chromophore element found in this glass (3.71% CuO). 3e: SEM pictures of K-glass from Tarragona (T-5) showing advanced glass decay caused by bio-pitting; note the curved-branched irregular pitting. (For interpretation of the references to colour in this figure legend, the reader is referred to the web version of this article.)

Stereomicroscope observations showed different situations on each glass sample. All glass samples, except T-28 (Cathedral of Tarragona) and STM-13 (church of Santa Maria del Mar), were covered by discontinuous orange and/or beige patina (Figs. 1C and 3A and C). In addition, glasses presented traces of biological activity as bio-pitting (Fig. 3A and B), isolate micro-cracks and some interconnected micro-cracks developed in glass, in patina, in old paints, or in grisaille (Fig. 3C).

SEM observations of the glass corroborated the morphology and evolution of pits (Fig. 3B and D), and the advanced glass decay. Fig. 3D shows initial development of curved-branched irregular pitting not directly related to cracking surface. Each pit appears as an incipient nodule-like glass decay form overprinted on the curved branch of pit progression. These branches of pits tend to coalesce and provide a deeply penetrated upper film of the glass, sometimes associated with an external surface patina. We could also observe that in plaqué glass the bio-pitting stopped when the microorganisms arrived at the colored layers, which contain heavy metals – e.g., copper – that are noxious to microorganisms (Fig. 3C). The diameter of the pit holes decreases from the external (50 μ m) to the internal part (20 μ m, Fig. 3C). This activity was also observed in the K-rich glass STM-16 (Fig. 3D). Fig. 3E shows a macroscopic photograph with a bio-pitting arrangement made in the glass surface, and SEM shows the detail of the pit hole section related to organic activity.

flashed glasses (Fig. 3E), the microbial development was stopped when the organisms reached the Cu-rich colored layer and, thus, they stopped their destructive activity. In those samples showing ancient bio-activity, we observed a non-uniform spatial distribution of pitting on the surface of the glasses. In some cases, the bio-pitting formed a pattern of channels like those shown in Fig. 3E.

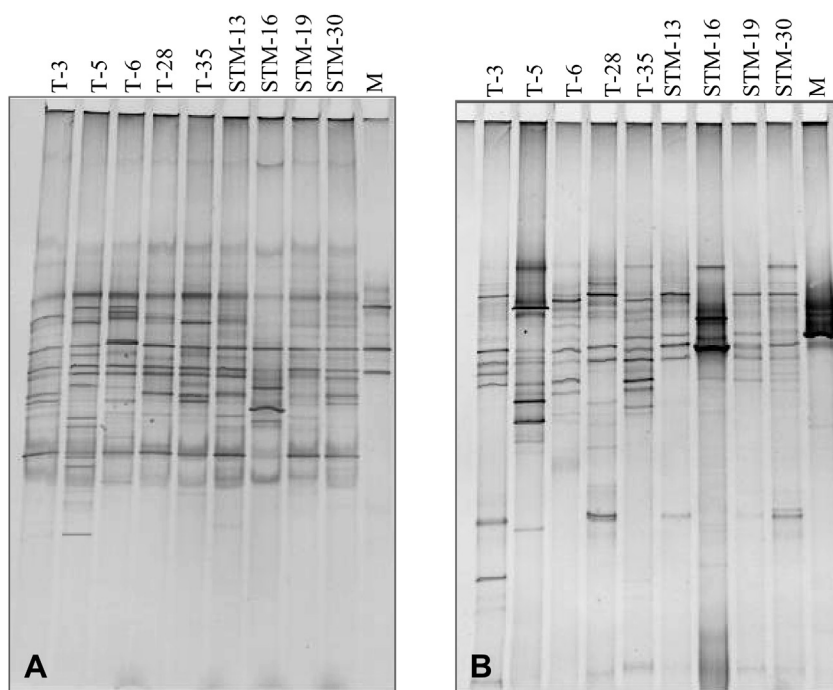
Fig. 4. DGGE fingerprints of DNA fragments encoding bacterial 16S rDNA, using a linear gradient of denaturants of 25–60% (A) and the fungal ITS1 region, using a linear gradient of denaturants of 20–50% (B) derived from original stained glass window samples of the Cathedral of Tarragona and the church of Santa Maria del Mar. Numbers of lanes represent the different glass samples. T: Tarragona; STM: Santa Maria del Mar. M: marker: a mixture of *Bacillus pumilus*, *Pseudomonas stutzeri*, and *Myxococcus xanthus* (A), *Cladosporium* sp. (B).

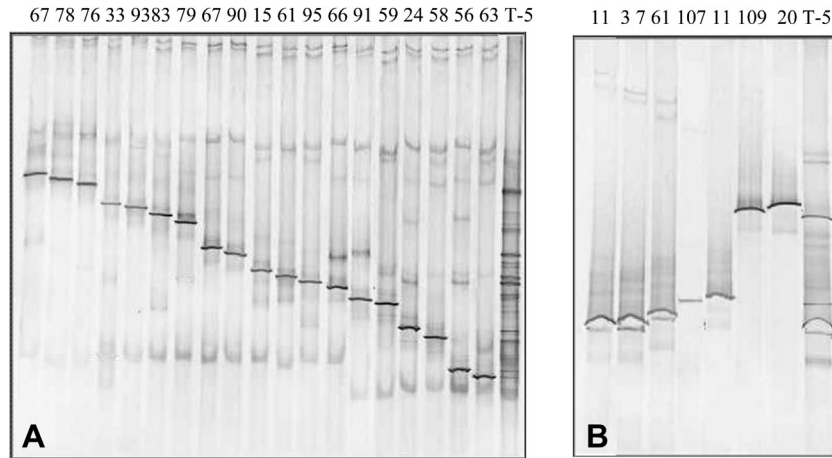
Fig. 5. DGGE fingerprints of DNA fragments encoding the bacterial 16S rDNA, using a linear gradient of denaturants of 25–55% (A) and the fungal ITS1 region, using a linear gradient of denaturants of 20–40% (B) derived from sample T-5 of the Cathedral of Tarragona, as well as the profiles of sequenced clones. Nomenclature indicates the numbers of clones, as indicated in Tables 3 and 4.

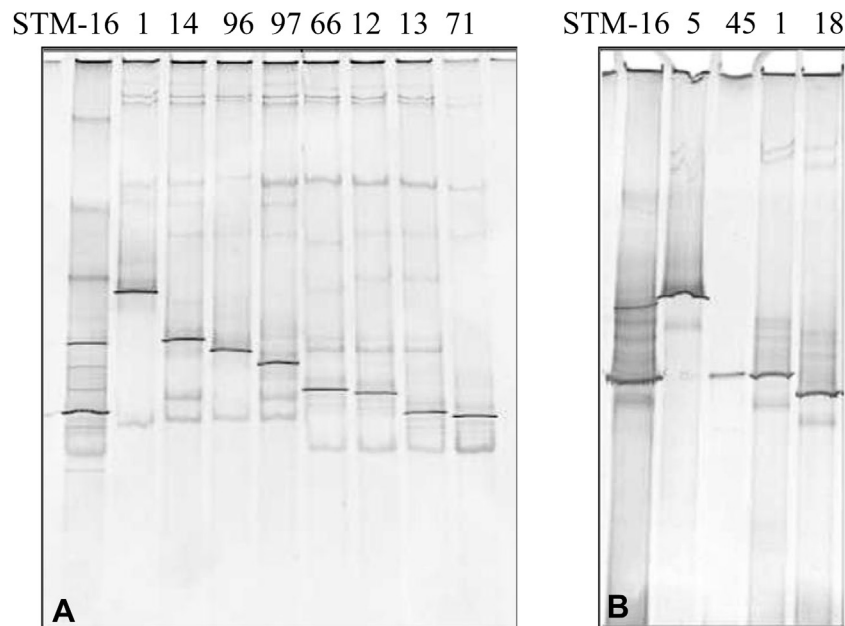
Fig. 6. DGGE fingerprints of DNA fragments encoding the bacterial 16S rDNA, using a linear gradient of denaturants of 25–55% (A) and the fungal ITS1 region, using a linear gradient of denaturants of 20–40% (B) derived from sample STM-16 of the church of Santa Maria del Mar, as well as the profiles of sequenced clones. Nomenclature indicates the numbers of clones as indicated in Tables 3 and 4.
